Yesler Terrace Renovation Cost Analysis

January 28, 2011

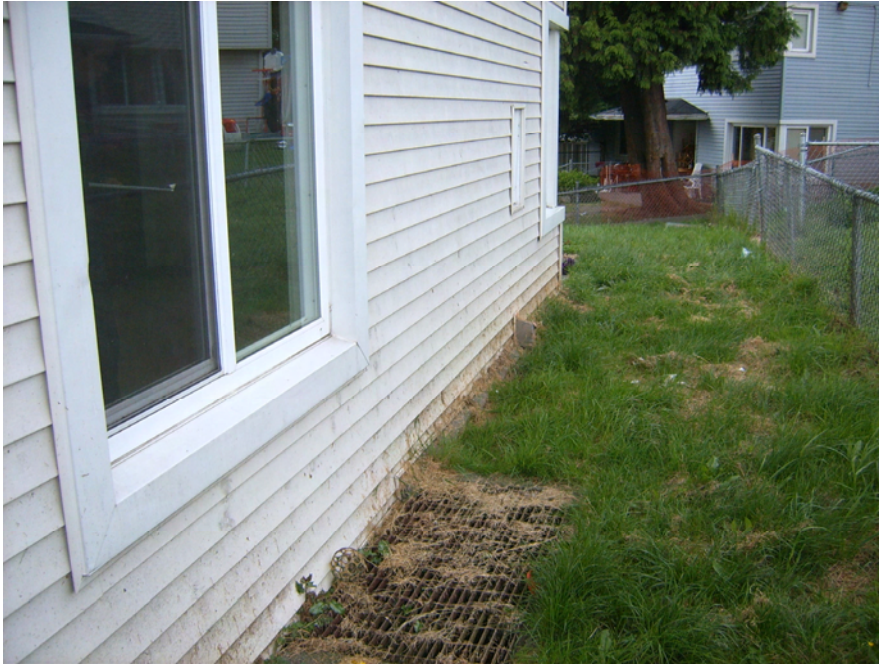
There are several areas around the perimeter of this building that do not appear to have good drainage which may be causing water intrusion into the wall cavity (Photograph #2).

Photograph #2 – Unit 631 Poor Drainage

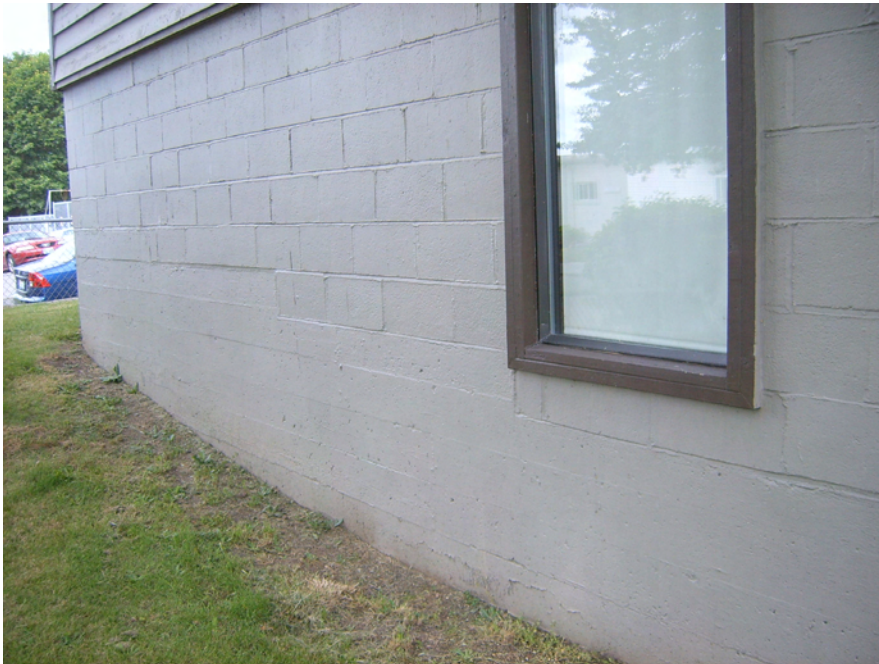
These units are part of a three-story multi-unit building in Section S. Most of the first floor walls are constructed with reinforced concrete and CMU (Photograph #3).

Photograph #3 – Unit 833 & 835 First Floor Walls

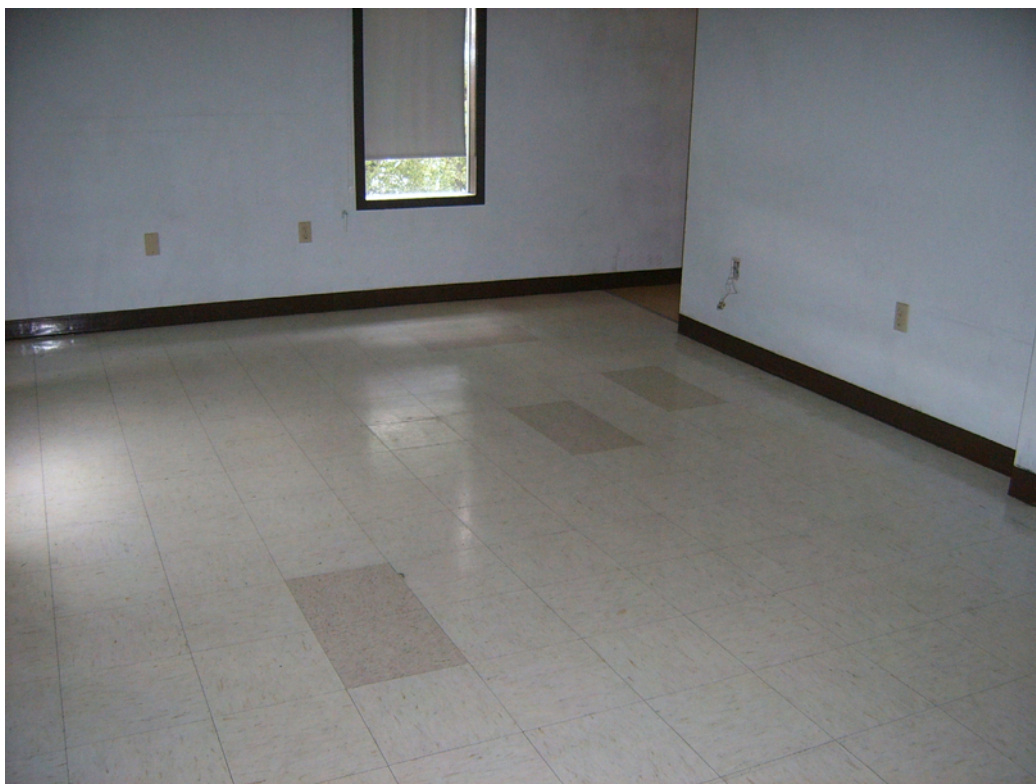
The unit walls above the second floor are framed with nominal 2x wood studs at 16 inches on center. The ground floor of this unit is a conventional slab-on-grade and the upper floors are framed with nominal 4x tongue and groove decking spanning between wood beams and stud walls. The upper floors of this unit are sagging noticeably (Photograph #4). The floors were checked using a carpenter's level to determine the maximum slope of the floor.

Photograph #4 – Unit 833 & 835 Floor Sag

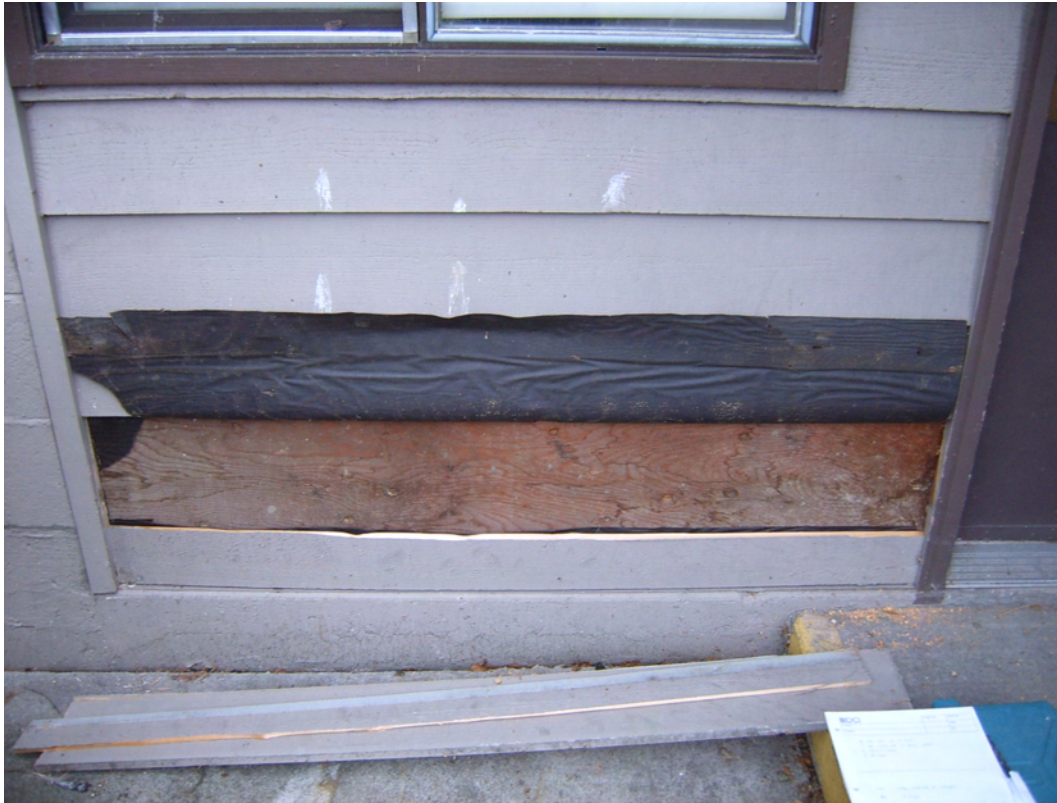
These units and the rest of the units in this building have newer cedar siding applied over 3/8 inch thick plywood backing. The plywood is nailed to the wall studs with a minimal number of nails that do not meet structural requirements for seismic force resistance (Photograph #5). There is also evidence of water intrusion into the wall cavity at wall corners and door openings. The interior walls of this unit are all sheathed with gypsum board.

Photograph #5 – Inadequate Exterior Sheathing Attachment

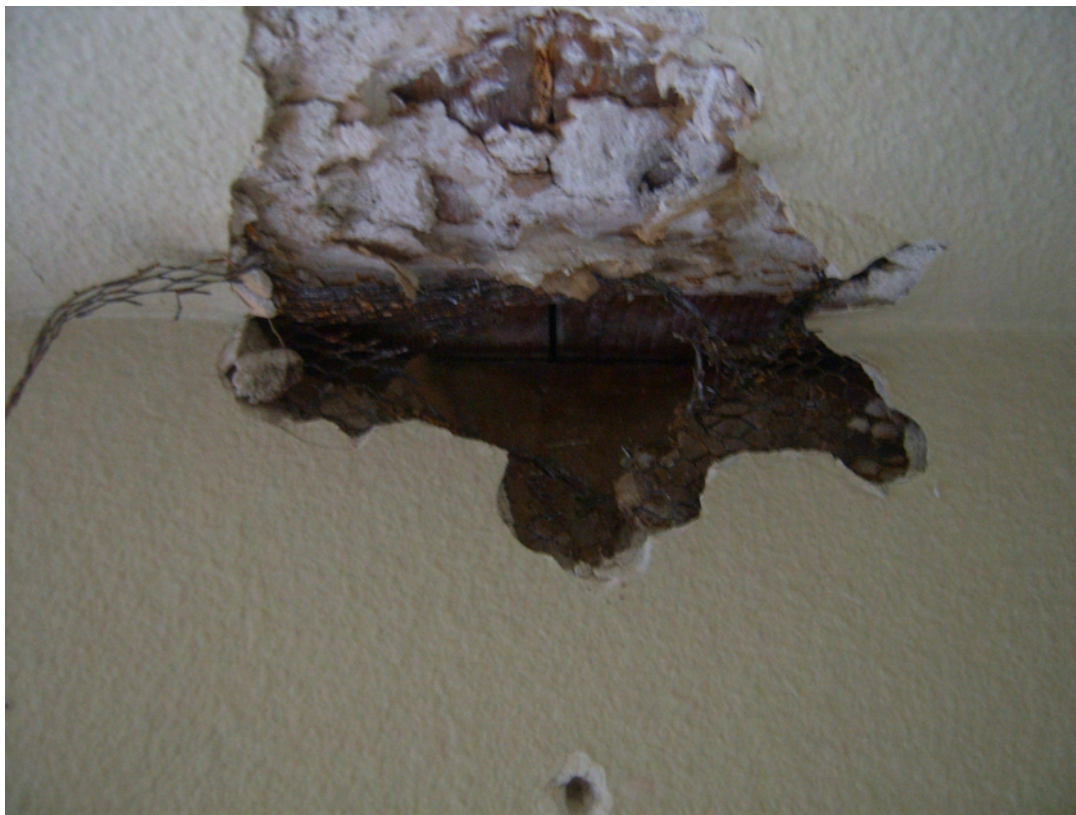
The ground floor of this unit is a conventional slab-on-grade and the upper floors are framed with nominal 4x tongue and groove decking spanning between wood beams and stud walls (Photograph #6).

Photograph #6 – Unit 439 Floor Framing

There is a noticeable sag in the ceiling and there are several cracks in the plaster that have widened due to the sag in the floor.

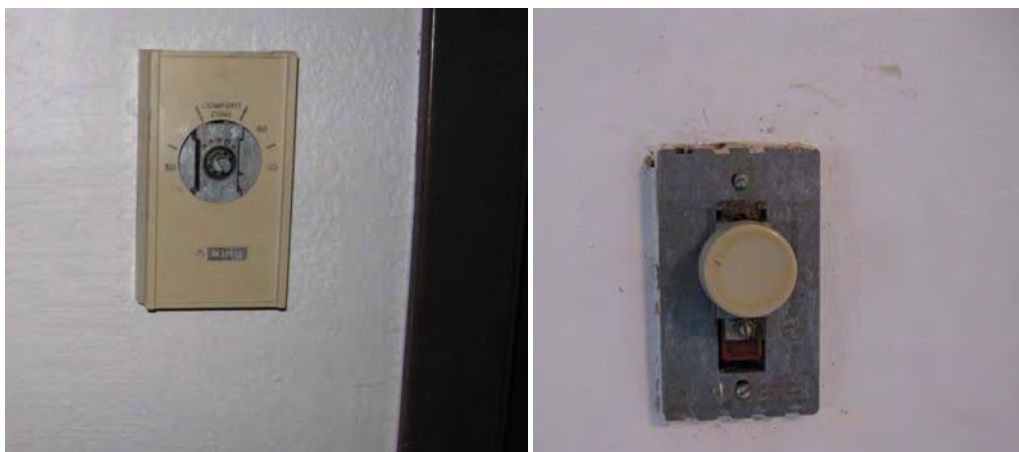
This unit has newer vinyl frame, double pane windows. Baseboard heaters appear to be in reasonable condition with some dents and scratches. One baseboard in particular needs its control panel re-attached in order to keep the wiring covered. Some wall thermostats are missing cover plates or control knobs and need to be replaced as Photo 1 below illustrates.

Photo 1 Wall Thermostats

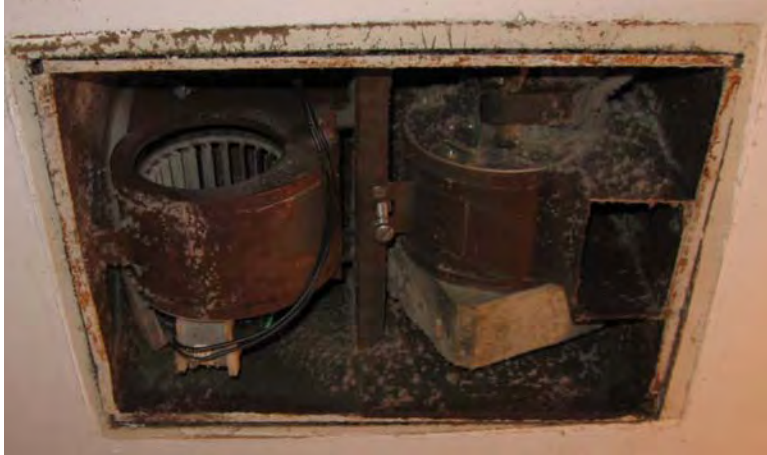
Shown in Photo 2, the bathroom exhaust fan is very poor shape and needs to be replaced. The shower and tub combination and lavatory are all in poor condition and need to be replaced.

Photo 2 Bathroom Exhaust Fan

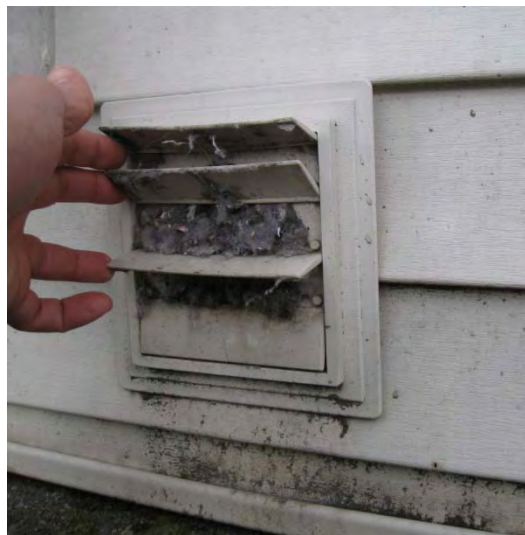
It is apparent that the clothes dryer lint trap was not maintained as it should have been, see Photo 3 below. The wall termination was completely obstructed by lint build-up,

Photo 3 Dryer Exhaust Termination with Lint Build-up

therefore restricting dryer airflow. This is a fire hazard and needs to be thoroughly cleaned before the space is leased. Additionally, this is an improper type of wall cap to be used for this application. This should be replaced with one which has a single backdraft damper blade.

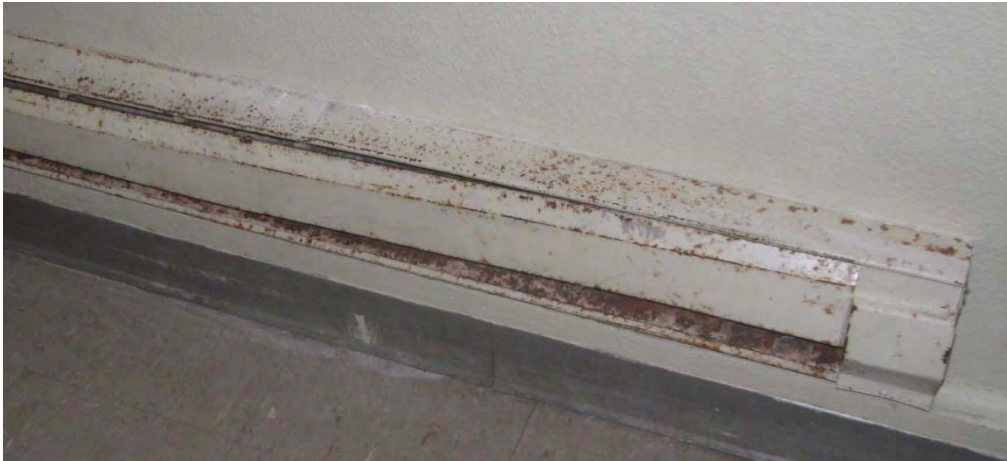
Photo 4 Baseboard Heater in Poor Condition

baseboard heaters are in very bad condition, as seen in the Photo 4, and need to be replaced. Their respective wall mounted thermostats also need replacement.

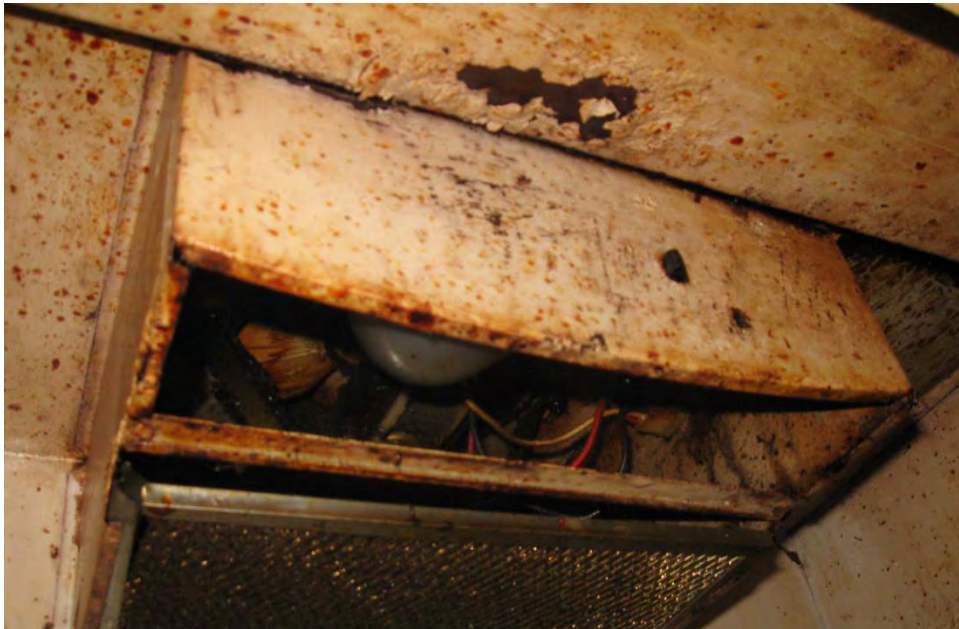
The kitchen range hood (see Photo 5), sink and fixture are in poor condition and all need to be replaced.

Photo 5 Kitchen Rangehood Exhaust Fan

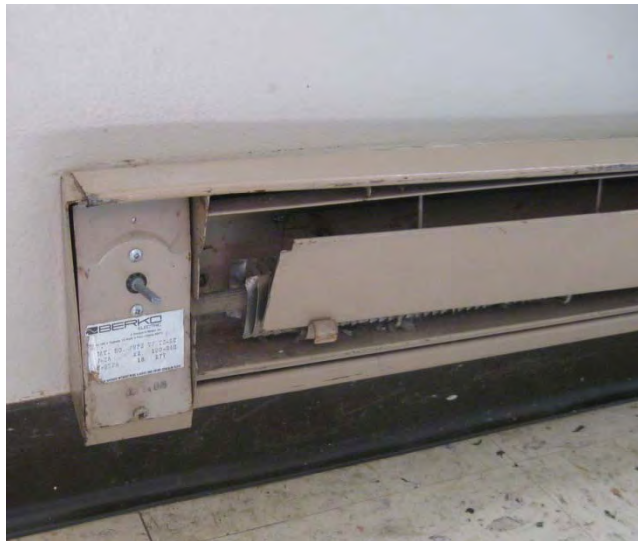
Ventilation is provided by operable windows in the living areas and bedrooms. Windows are vinyl frame with double pane glazing. Electric baseboard heaters and thermostats are in fair condition, except one baseboard that is damaged and needs to be replaced, see Photo 6. The face plate does not completely cover the heating elements and is a fire hazard.

Photo 6 Electric Baseboard Heater with Panel Cover

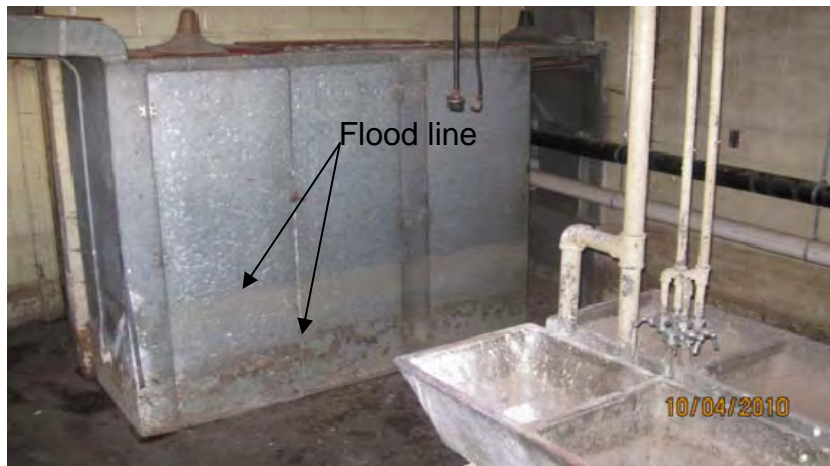
As seen in Photo 7, this basement area has been flooded. A visual inspection should

Photo 7 Basement Area with Abandoned Existing Laundry Facility

be performed regularly to verify if the basement area is flooding currently or if this was an issue that was resolved in the past.

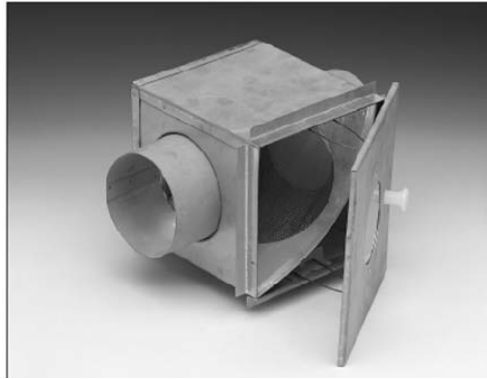
Picture 1 Secondary Dryer Lint Trap

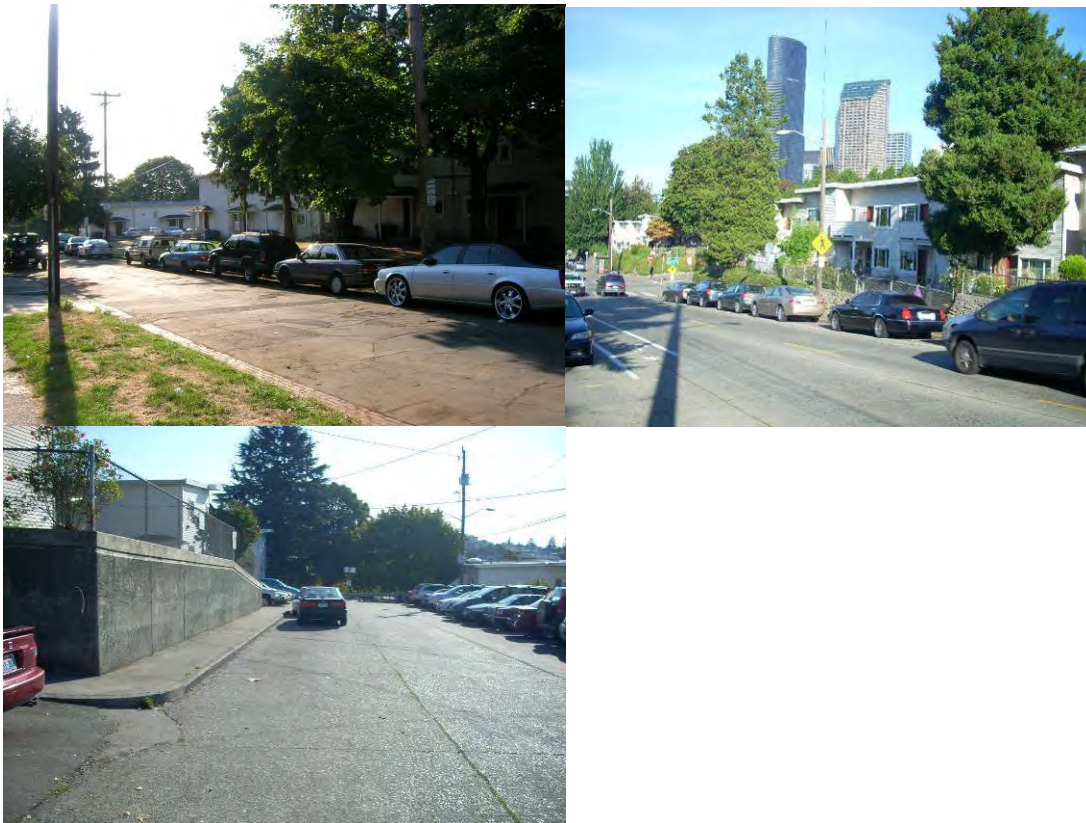
The asphalt roads are in fair to poor shape. East Fir Street appears to be an asphalt overlay on an existing brick road. The asphalt is cracking and deteriorating in several locations. The other asphalt roads are also showing signs of base failure with the cracking of the asphalt surfacing.
