BLOCK 7 SOUTH ABATEMENT AND DEMOLITION Solicitation No. 5143

ADDENDUM NO. 3
Issue Date: January 25, 2019

Hazardous Materials Survey

"Building #18"
121 8th Avenue
Seattle, WA 98104

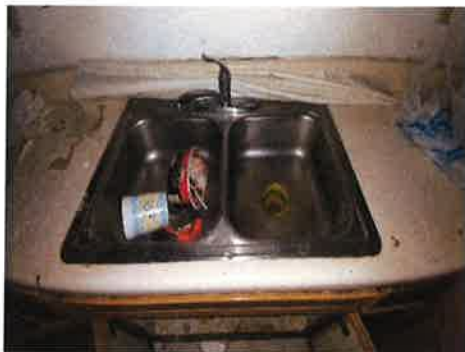
Sample numbers: 2018-0913-3-12 & 3-25

3. Black sink undercoating (Non-friable)

There is a total of three (3) aluminum sinks with asbestos containing black undercoating located in room 5, 14, and 30 of building #18.

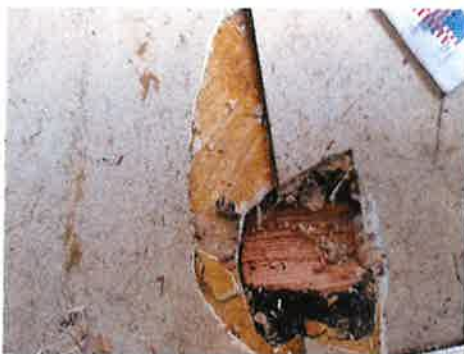
Sample number: 2018-0913-3-16

6. 12x12 White vinyl floor tiles (Non-friable)

There is approximately 175 square feet of asbestos-containing 12x12 white vinyl floor tiles located in room 7, 8, and 9 of building #18. The associated mastic is not asbestos containing. The substrate is wood.

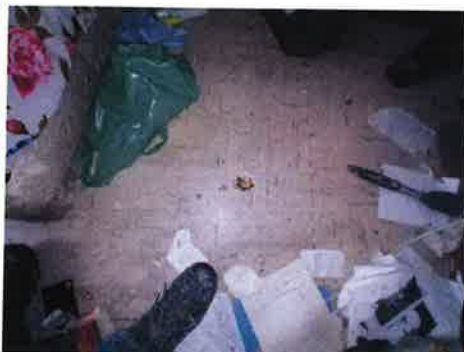
Sample number: 2018-0914-3-9

3. Beige vinyl floor tiles (Non-friable)

There is approximately 300 square feet of asbestos-containing beige vinyl floor tiles located in room 5 thru 7 of building #19. The associated black mastic is not asbestos containing. The substrate is wood.

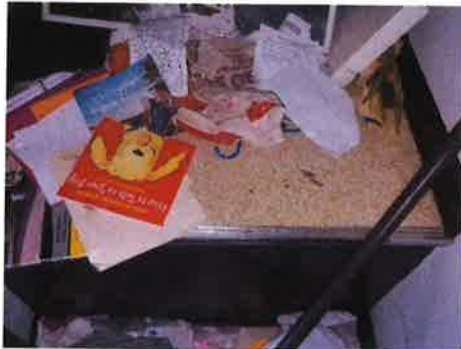
Sample numbers: 2018-0914-3-10, 3-12

4. Tan sheet vinyl backing / mastic (Friable)

There is approximately 95 square feet of asbestos-containing off-white backing with mastic associated with tan sheet vinyl flooring located on the shelf in room 5 & 13 and in room 8 (under beige sheet vinyl) of building #19. The substrate is wood.

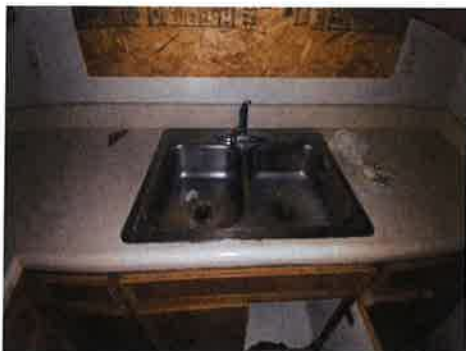
Sample numbers: 2018-0915-3-9, 3-47, & 3-59

3. Black sink undercoating (Non-friable)

There is a total of six (6) aluminum sinks with asbestos containing black undercoating located in rooms 3, 12, 20, 36, 44, & 52 of building #20.

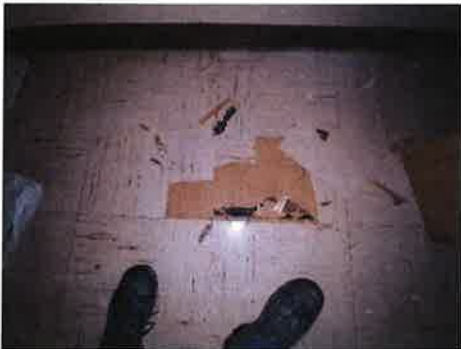
Sample numbers: 2018-0915-3-40, 3-52, 3-56, & 3-61

5. Beige / brown / tan vinyl floor tiles / black mastic (Non-friable)

There is approximately 570 square feet of asbestos-containing beige / brown / tan vinyl floor tiles with black mastic located under vinyl floor tiles in room 33, 49, 51, 53, 54, & 55 of building #20. The substrate is wood.

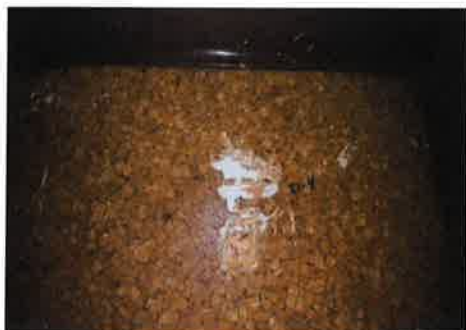
Sample numbers: 2018-0916-3-4, 3-25, 3-43 & 3-71

2. Brown sheet vinyl backing / mastic (Friable)

There is approximately 140 square feet of asbestos-containing off-white backing with mastic associated with brown sheet vinyl flooring / steps located in rooms 1, 25, 48 & 78 of building #21. The substrate is wood.

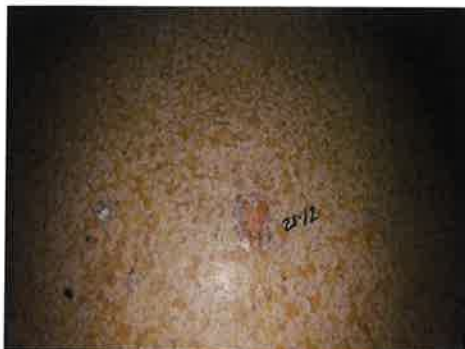
Sample numbers: 2018-0916-3-12, 3-16, 3-19, 3-31, 3-39, 3-45, 3-51, 3-65, 3-74

5. Tan sheet vinyl backing / mastic (Friable)

There is approximately 325 square feet of asbestos-containing white backing with mastic associated with tan sheet vinyl flooring located in rooms 7, 13, 19, 31, 42, 49, 54, 74, 79 of building #21. The substrate is wood.

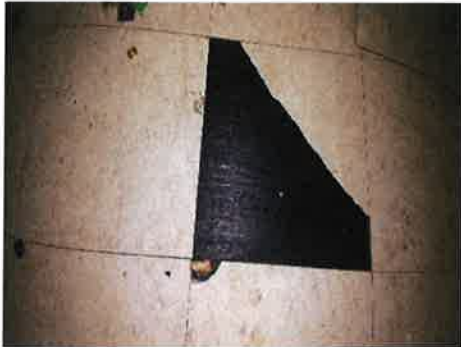
Sample number: 2018-0916-3-34

6. Black floor mastic (Non-friable)

There is approximately 235 square feet of asbestos-containing black floor mastic associated with white vinyl tiles in rooms 33 & 35 of building #21. The substrate is wood.

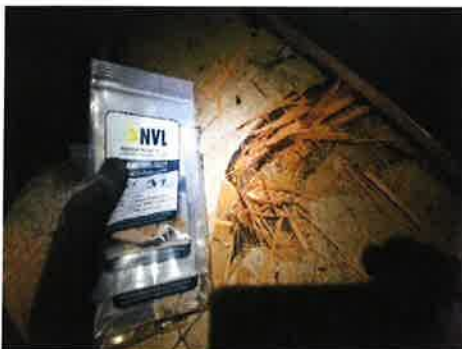
Sample numbers: 2018-0917-3-9, 3-27

3. Beige vinyl floor tiles (Non-friable)

There is approximately 635 square feet of asbestos-containing beige vinyl floor tiles located under white vinyl floor tiles in room 1, 5, 6, 20, 23, 24 of building #22. The associated mastic is not asbestos containing. The substrate is wood.

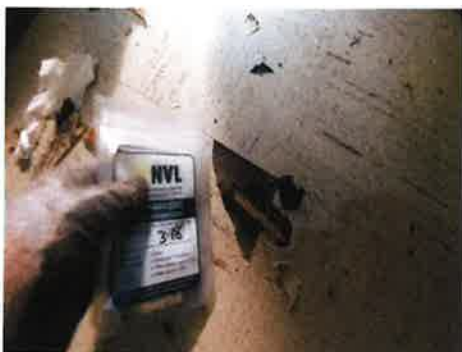
Sample number: 2018-0917-3-18

There is approximately 70 square feet of asbestos-containing black floor mastic associated with white vinyl floor tiles in rooms 14 of building #22. The substrate is wood.
