Yesler Terrace Renovation Cost Analysis

January 28, 2011

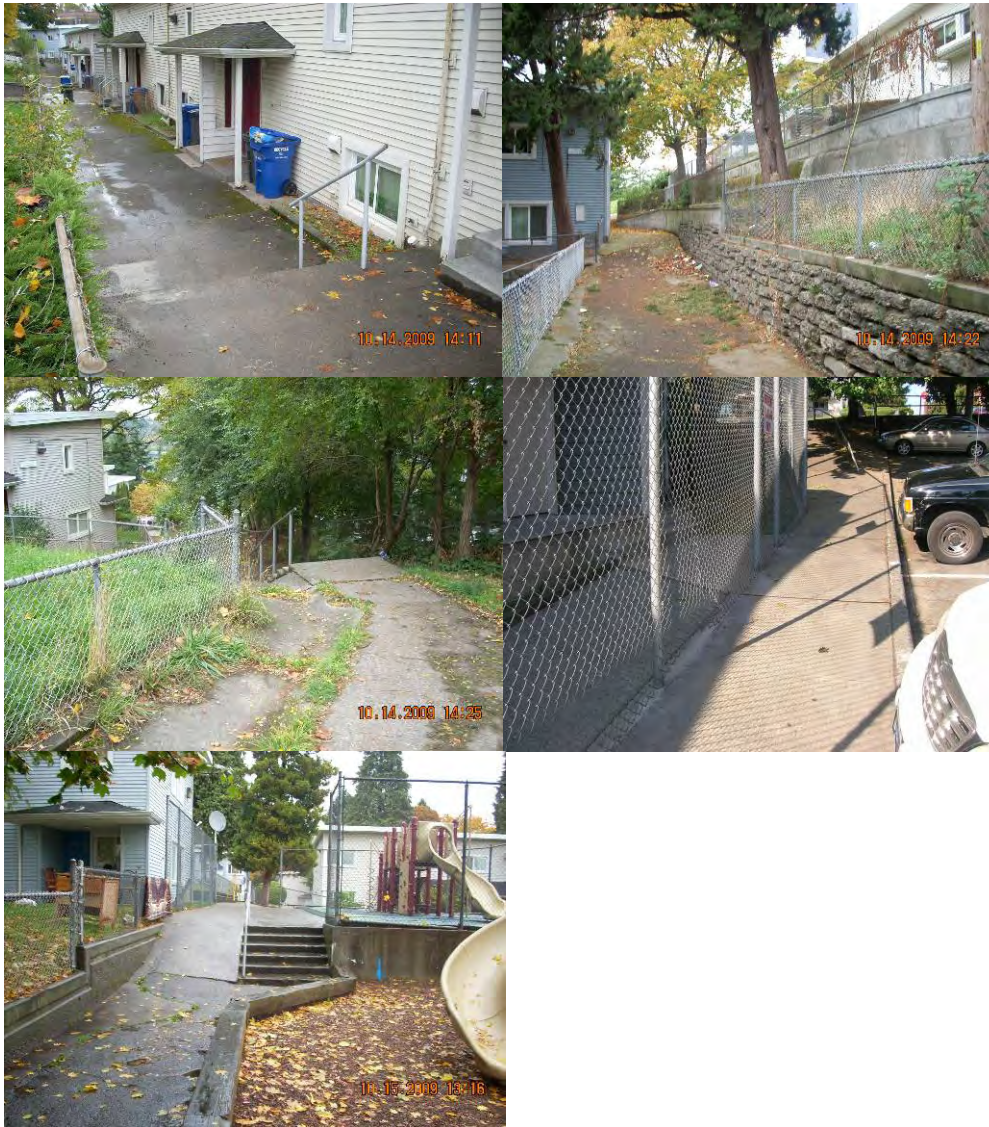
The internal walkways within the Yesler Terrace Community are in poor condition. The walks have also settled unevenly over time. Lips at pavement joints and cracks in areas of deteriorating pavement produce abrupt grade changes which are greater than the 1/2-inch ADA maximum. The sidewalks are narrow. Several walk areas pond during wet weather. As the Yesler Terrace Community is located on a hillside, the majority of the units are not ADA accessible due to steep gradients and/or stairs that are required for residents to access their units from parking areas or street access. Pathways frequently have slopes (both longitudinal and cross) that exceed ADA grades. Most of the stairways throughout the site do not meet ADA requirements for the number of handrails (minimum two per stairway) and the placement.

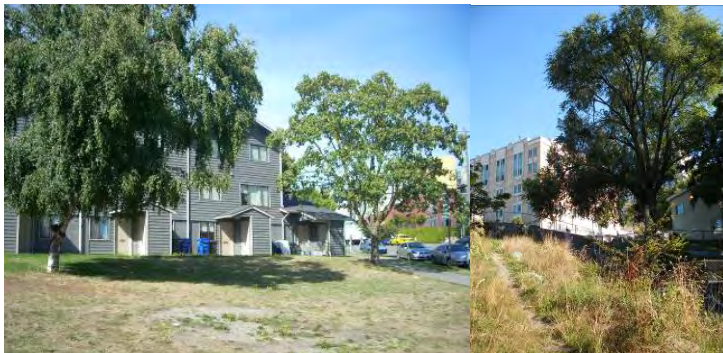
Other than the trees, the site’s vegetation is relatively sparse and unevenly distributed, with few shrubs or groundcovers. Ivy and other invasive species exhibit a strong presence. Most open areas consist of patchy lawn and exposed soils flanked by cracked paving. Garbage scraps and litter are scattered across some of the less well-maintained areas. As a result, many of the site’s open areas feel empty and uncared for, despite the spreading canopy of some larger trees.

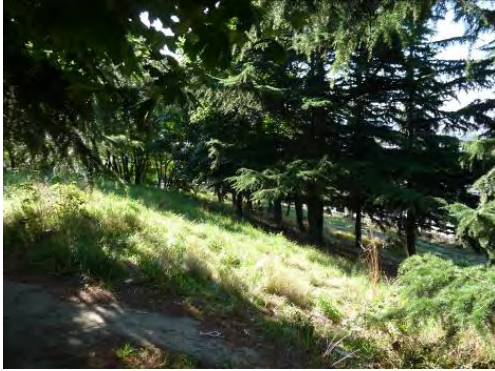
Along the western edge of the community above I-5, there is a steep, coniferous buffer zone through which informal trails have been established. This area is somewhat secluded from the rest of the site. Garbage is scattered throughout and there are indications that the buffer zone is used as a camp site by the homeless. The area's unmaintained character suggests that it gets little regular use by residents and may be perceived as unsafe.

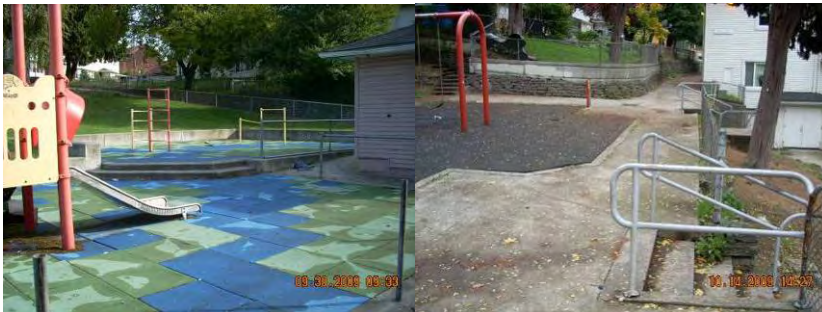
In addition to the recreational uses near the community center, there are four smaller play areas within the residential block clusters. Although no doubt intended to foster community interaction and to provide smaller gathering spaces for children and young families, these areas feel abandoned. Vegetation consists of patchy grass with few shrubs; the hardscape is old, stained concrete flanked by concrete rubble retaining walls topped with chain link fences.

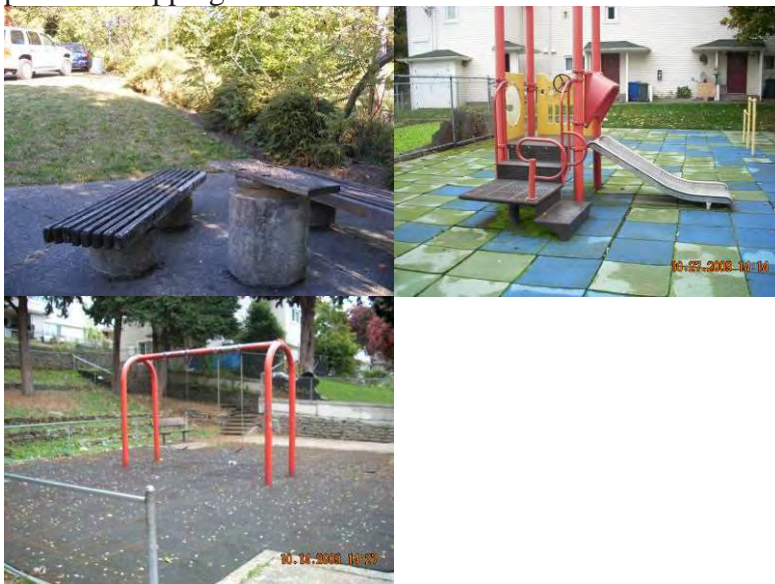
Site furnishings include benches made of wood slats on concrete posts or of metal, as well as metal garbage cans. There are few exterior tables and some of the table tops are missing. Most of the benches and tables show signs of heavy deterioration and have reached the end of their useful lives. While brightly painted, the playground equipment (installed in the mid-1990's) in the smaller play areas between the building clusters is nearing the end of a useful lifespan. The play equipment is installed over rubber tiles as safety fall surfacing. Some of the rubber tiles have edges that are curling up, introducing potential tripping hazards.

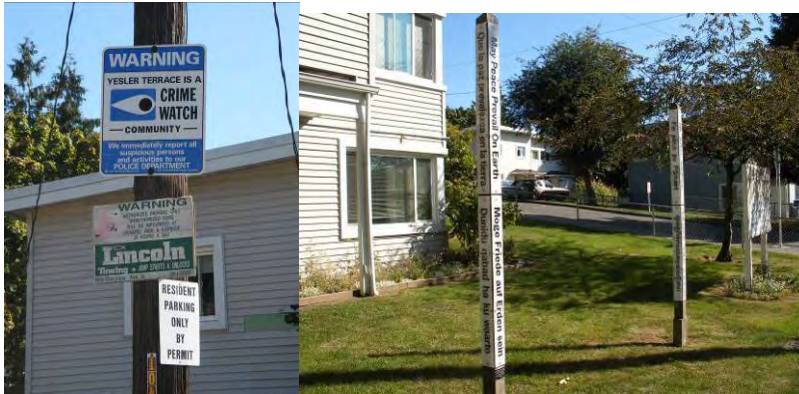
Yesler Terrace contains little signage, other than worn parking, “crime watch” and warning signs. This contributes to the feeling that Yesler Terrace is an undefined space. No signs herald entry into the development and there is no coherent wayfinding system that defines Yesler Terrace as a neighborhood or helps the general public navigate the site.

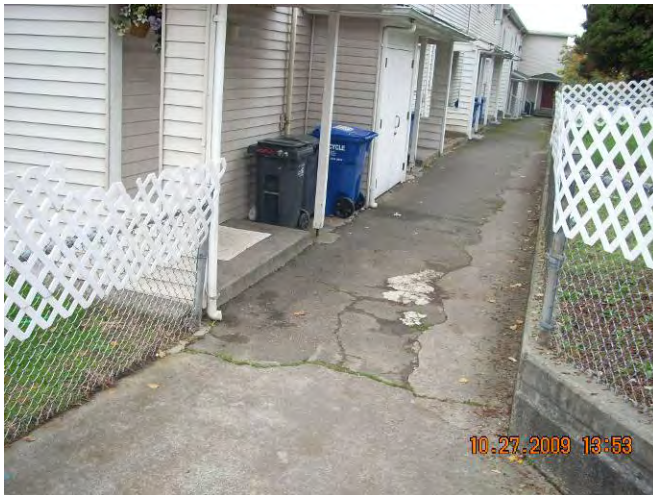
The existing private storm drainage system at Yesler Terrace site was installed in the early 1940’s with the construction of the Yesler Terrace housing complex. The storm drain system includes catch basins, inlets, building roof downspouts and conveyance pipes ranging from 6 to 12 inches. In the late 1990s, SHA replaced/or repaired most of the side sewer connections from the buildings to the site’s main side sewers. Included in this work was the replacement of the many downspout connections to the side sewers. There are still a few downspouts that discharge to the surface. SHA maintenance staff reported that several of the existing catch basins located on the site are filled with debris or are not located at low points. This condition causes localized ponding of water within or near interior walkways during wet weather conditions.
