BLOCK 7 SOUTH ABATEMENT AND DEMOLITION Solicitation No. 5143

ADDENDUM NO. 3
Issue Date: January 25, 2019

Hazardous Materials Survey

"Building #18"
121 8th Avenue
Seattle, WA 98104

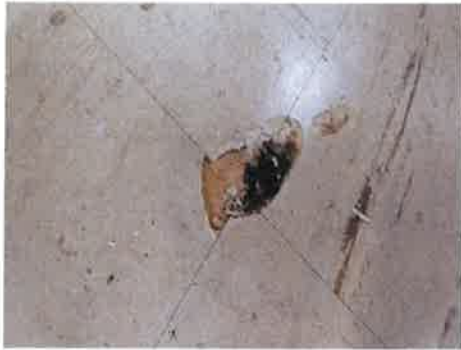
1. Beige vinyl floor tiles (Non-friable)

Sample numbers: 2018-0913-3-6, 3-19,
3-22, 3-27, 3-32, 3-35

There is approximately 900 square feet of asbestos-containing beige vinyl floor tiles located under 12x12 white vinyl tile flooring in room 3, 11, 12, 13, 15, 16, 17, 19, and 23 thru 25 of building #18. The associated mastic is not asbestos containing. The substrate is wood.

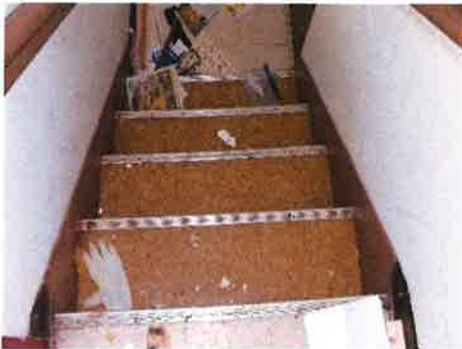
2. Brown sheet vinyl backing / black mastic (Friable)

Sample numbers: 2018-0913-3-7, 3-20

There is approximately 140 square feet of asbestos-containing white backing with black mastic associated with brown sheet vinyl flooring / steps located in room 3, 11, 19, and 27 of building #18. The substrate is wood.

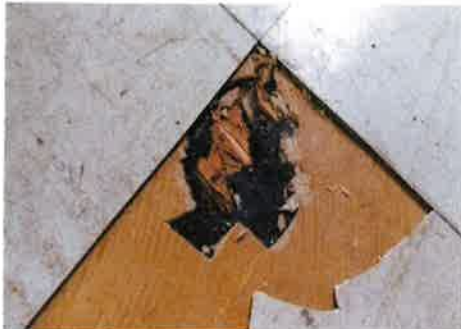
4. Beige vinyl tiles / black mastic (Non-friable)

Sample number: 2018-0913-3-14

There is approximately 140 square feet of asbestos-containing beige vinyl floor tiles with black mastic located under 12x12 white vinyl tile flooring in room 6 (including the closet) of building #18. The substrate is wood.

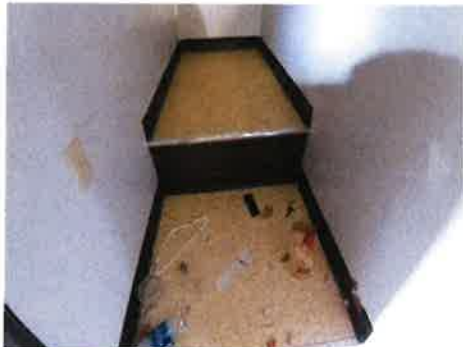
5. Cream sheet vinyl backing / mastic (Friable)

Sample numbers: 2018-0913-3-15, 3-18, 3-26, 3-37

There is approximately 200 square feet of asbestos-containing backing with mastic associated with cream sheet vinyl flooring and shelf flooring located in room 6 (closet), 15, 23, 31, 32, and under tan sheet vinyl in room 10 & 18 of building #18. The substrate is wood.

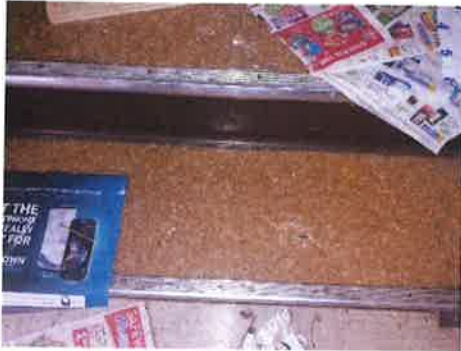
1. Brown sheet vinyl backing / mastic (Friable)

Sample number: 2018-0914-3-3

There is approximately 75 square feet of asbestos-containing off-white backing with tan mastic associated with brown sheet vinyl flooring / steps located in room 1 & 9 of building #19. The substrate is wood.

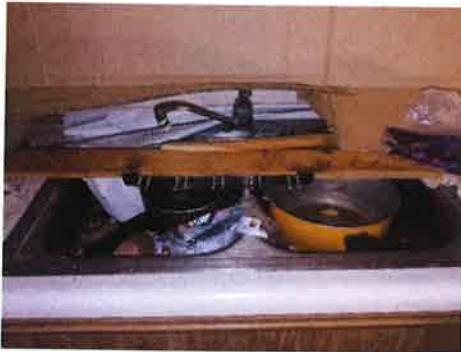
2. Black sink undercoating (Non-friable)

Sample numbers: 2018-0914-3-8 & 3-24

There is a total of four (4) aluminum sinks with asbestos containing black undercoating located in room 4, 12, 20, and 27 of building #19.

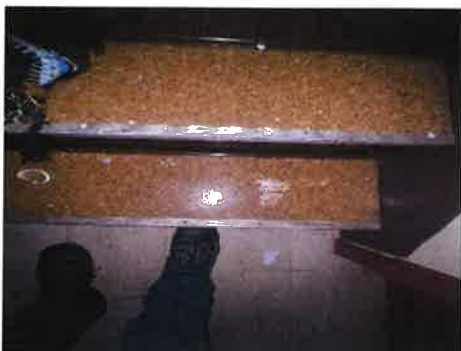
Sample numbers: 2018-0915-3-4, 3-46 & 3-53

1. Brown sheet vinyl backing / mastic (Friable)

There is approximately 255 square feet of asbestos-containing off-white backing with mastic associated with brown sheet vinyl flooring / steps located in rooms 1, 9, 17, 33, 41, 49 & 57 of building #20. The substrate is wood.

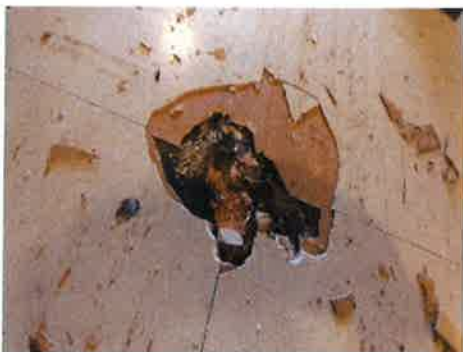
Sample numbers: 2018-0915-3-6, 3-16, 3-17, 3-19, 3-20, 3-23, 3-25, 3-27, & 3-68

2. Brown / tan / beige vinyl floor tiles (Non-friable)

There is approximately 1,580 square feet of asbestos-containing brown / tan / beige vinyl floor tiles located under vinyl floor tiles in rooms 2, 9, 11, 13, 14, 15, 17, 19, 21, 22, 23, & 59 of building #20. The associated black mastic is not asbestos containing. The substrate is wood.

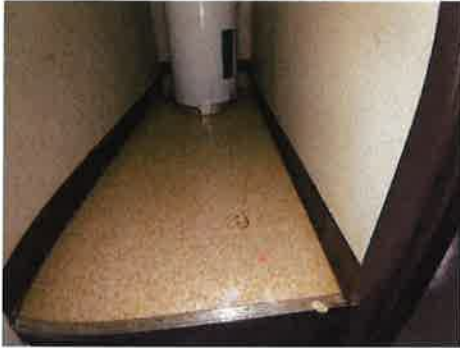
Sample numbers: 2018-0915-3-10, 3-14, 3-45, 3-51, 3-60, & 3-64

4. Beige sheet vinyl backing / mastic (Friable)

There is approximately 365 square feet of asbestos-containing off-white backing with mastic associated with beige sheet vinyl flooring located on the shelf in rooms 4, 13, 21, 53, 61 and on the floor in rooms 8, 24, 40, 48, 56, & 64 of building #20. The substrate is wood.

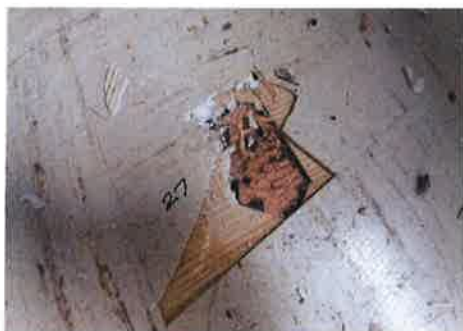
Sample numbers: 2018-0916-3-3, 3-32, 3-35, 3-40

1. White / beige vinyl floor tiles / black mastic (Non-friable)

There is approximately 370 square feet of asbestos-containing white / beige vinyl floor tiles with black mastic located under vinyl floor tiles in rooms 1, 12, 32, 34, & 43 of building #21. The substrate is wood.

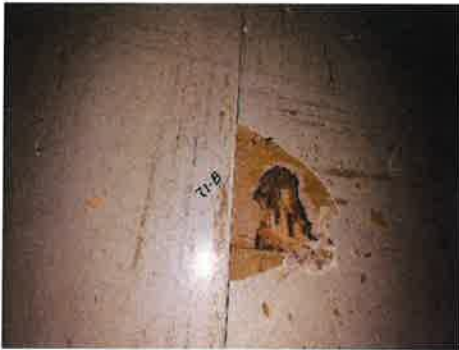
Sample numbers: 2018-0916-3-8, 3-15, 3-17, 3-20, 3-23, 3-24, 3-49, 3-50, 3-52, 3-53

3. White / beige vinyl floor tiles (Non-friable)

There is approximately 2340 square feet of asbestos-containing white / beige vinyl floor tiles located under vinyl floor tiles in rooms 3, 9, 10, 11, 14, 15, 17, 18, 20, 21, 23, 24, 25, 34, 36, 51, 52, 53, 55, 56, 58 of building #21. The associated mastic is not asbestos containing. The substrate is wood.

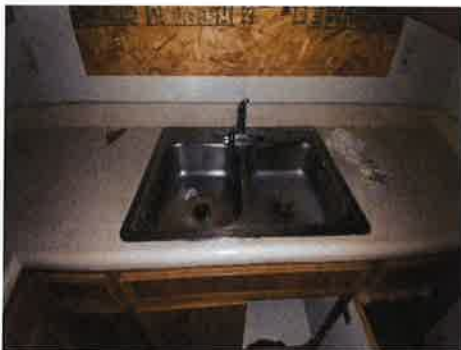
Sample numbers: 2018-0916-3-9, 3-33, 3-48, 3-67

4. Black sink undercoating (Non-friable)

There is a total of twelve (12) aluminum sinks with asbestos containing black undercoating located in rooms 3, 8, 14, 20, 27, 32, 43, 50, 55, 61, 67, 75 of building #21.

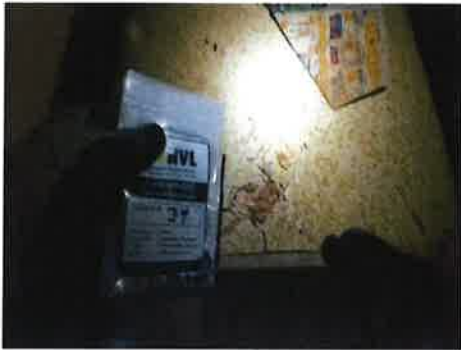
Sample numbers: 2018-0917-3-4, 3-14, 3-24

1. Tan sheet vinyl backing / mastic (Friable)

There is approximately 105 square feet of asbestos-containing white backing with mastic associated with tan sheet vinyl flooring located in room 3, 9, 21 of building #22. The substrate is wood.

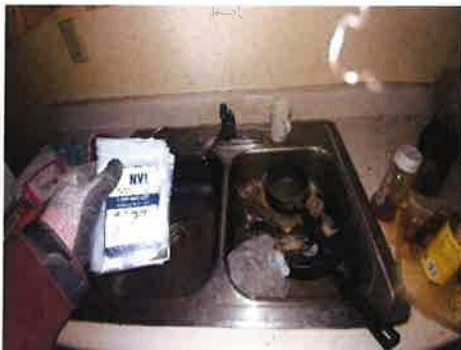
Sample numbers: 2018-0917-3-7, 3-26

2. Black sink undercoating (Non-friable)

There is a total of six (6) aluminum sinks with asbestos containing black undercoating located in room 4, 10, 17, 22, 28, 34 of building #22.

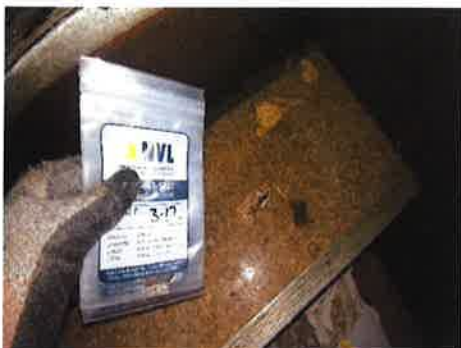
Sample numbers: 2018-0917-3-12, 3-19

4. Brown sheet vinyl backing / mastic (Friable)

There is approximately 60 square feet of asbestos-containing white backing with mastic associated with brown sheet vinyl flooring / steps located in room 7, 14 of building #22. The substrate is wood.

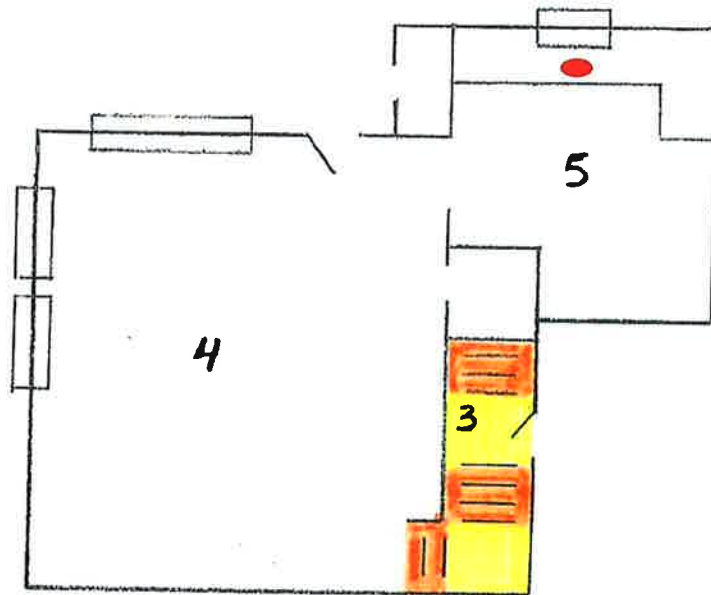
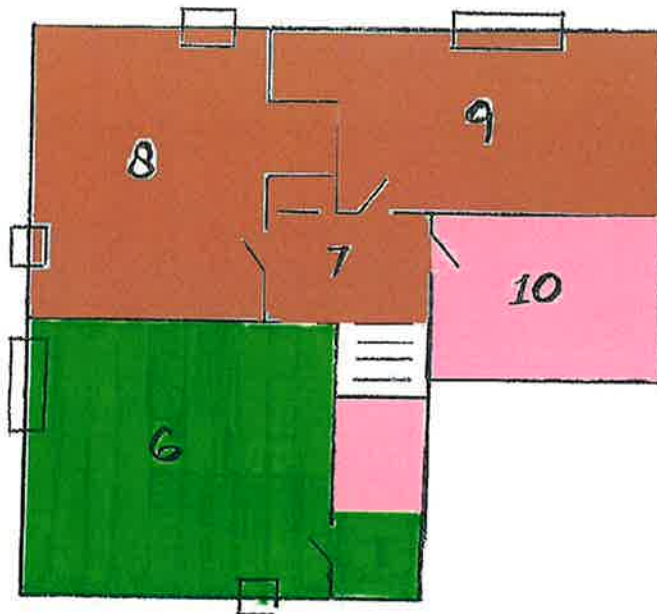
UNIT 165

-   Beige vinyl floor tiles
-   Brown sheet vinyl with black mastic
-   Black sink undercoating
-   Beige vinyl floor tiles with back mastic
-   Cream sheet vinyl with mastic
-   12x12 White vinyl floor tiles

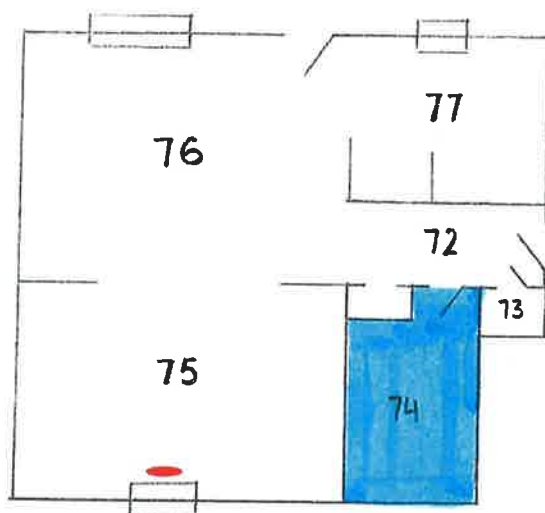
UNIT 204

- Floor tiles with black mastic
- Brown sheet vinyl flooring with mastic
- Floor tiles
- Black sink undercoat
- Tan sheet vinyl flooring with mastic
- Black floor mastic

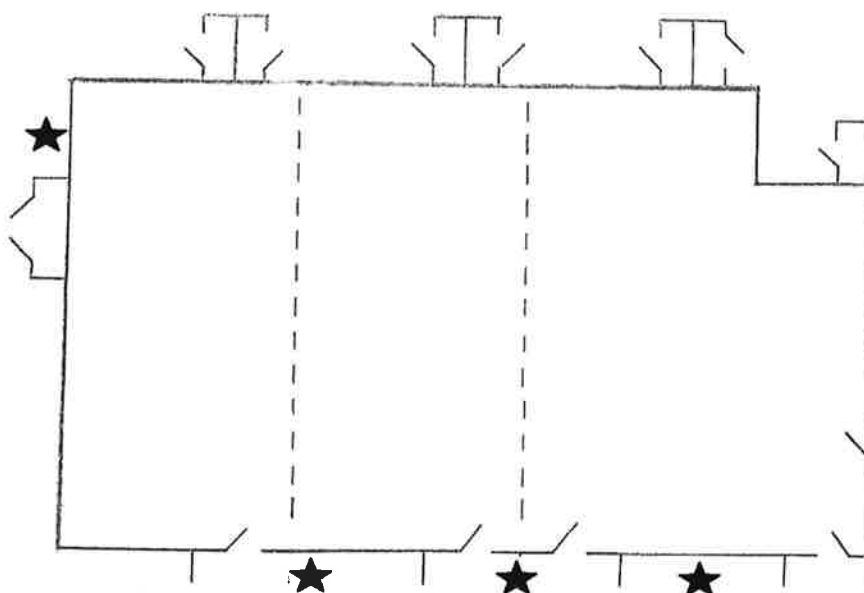
EXTERIOR

★ Mercury & PCB Devices

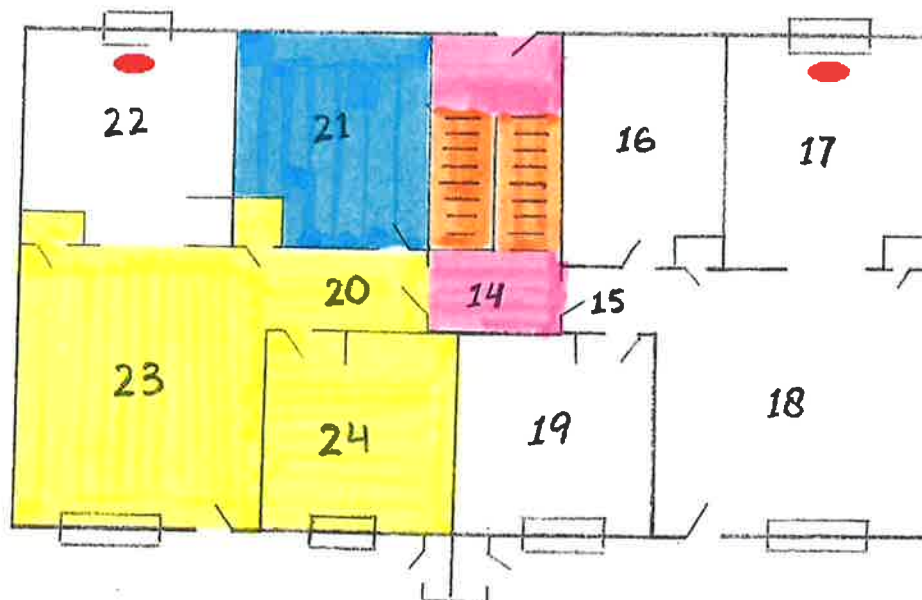
UNIT 210 UNIT 208

- Tan sheet vinyl flooring with mastic
- Black sink undercoat
- Beige floor tiles
- Brown sheet vinyl flooring with mastic
- Black floor mastic

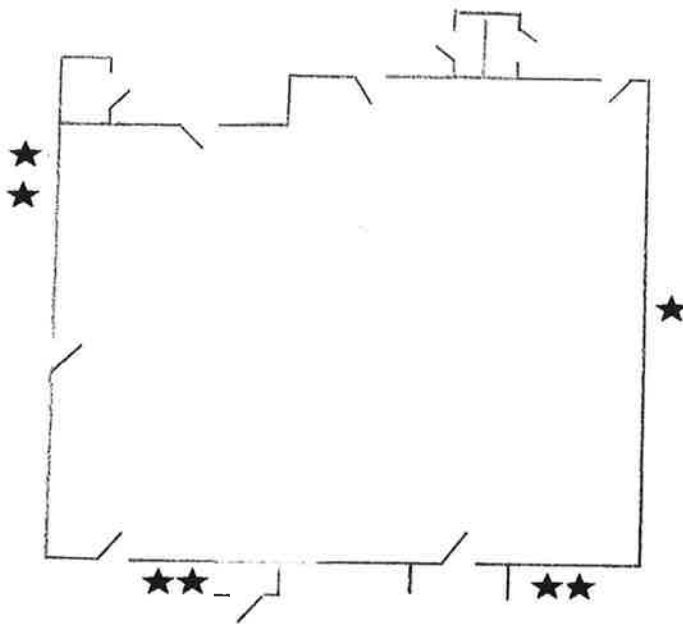
EXTERIOR

★ Mercury & PCB Devices
