Based on the results of the historical and regulatory data review and the site reconnaissance, sites of potential concern for the planned redevelopment project have been identified and are listed in Table 1 and highlighted on Figure 2. The sites are ranked based on an assessment of the potential for encountering contamination during the planned redevelopment project. As indicated in Table 1, the former TD Auto Body & Repair (currently Universal Auto Body & Services Inc.) is identified as having the highest potential to affect construction or redevelopment activities based on the potential for contamination to have migrated from this site to the subject property.

This technical memorandum has been prepared for the exclusive use of Collins Woerman Inc. and the Seattle Housing Authority for specific application to the Yesler Terrace Redevelopment project. No other party is entitled to rely on the information, conclusions, and recommendations included in this document without the express written consent of Landau Associates. Further, the reuse of information, conclusions, and recommendations provided herein for extensions of the project or for any other project, without review and aut

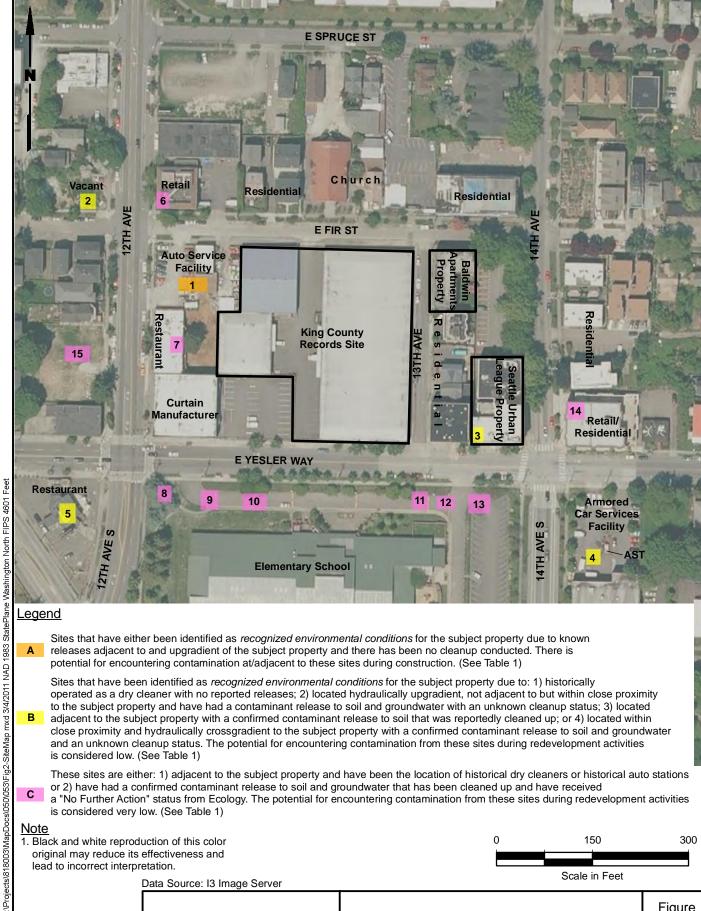
Legend

Sites that have either been identified as recognized environmental conditions for the subject property due to known releases adjacent to and upgradient of the subject property and there has been no cleanup conducted. There is potential for encountering contamination at/adjacent to these sites during construction. (See Table 1)

Sites that have been identified as recognized environmental conditions for the subject property due to: 1) historically operated as a dry cleaner with no reported releases; 2) located hydraulically upgradient, not adjacent to but within close proximity to the subject property and have had a contaminant release to soil and groundwater with an unknown cleanup status; 3) located adjacent to the subject property with a confirmed contaminant release to soil that was reportedly cleaned up, or 4) located within close proximity and hydraulically crossgradient to the subject property with a confirmed contaminant release to soil and groundwater and an unknown cleanup status. The potential for encountering contamination from these sites during redevelopment activities is considered low. (See Table 1)
